Altec Digger Derrick Pedestal Failure: **Immediate Action Required!**

Date of Incident: 2/20/2023

Incident: Turret failure

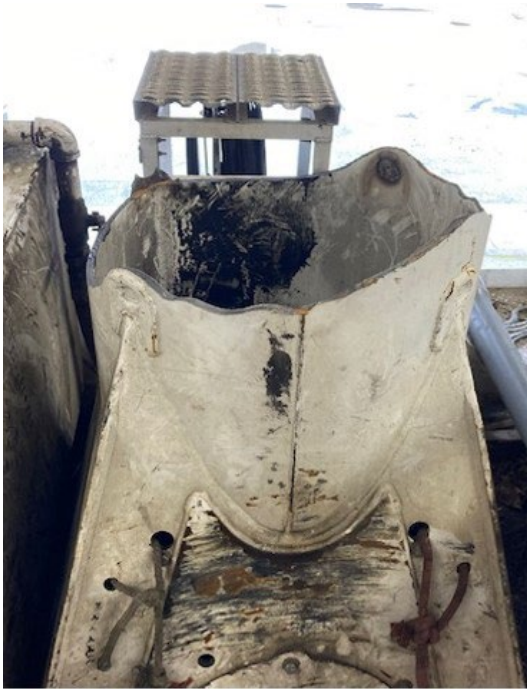
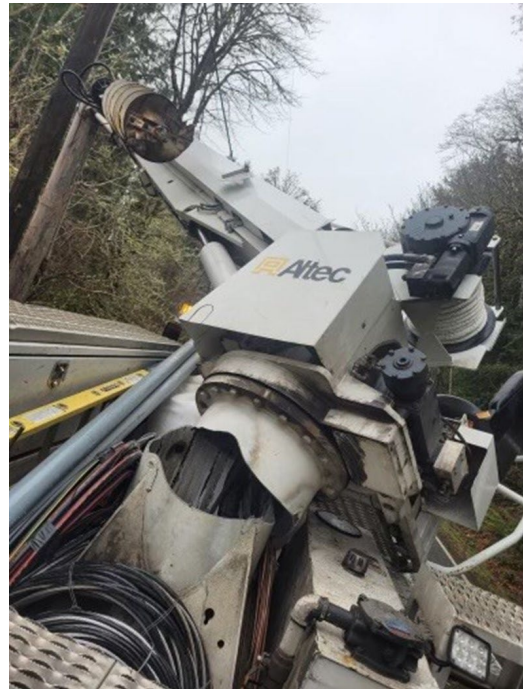
Due to this incident, a second Altec Digger Derrick has been found that shows similar metal fatigue indicators (a cracked gusset support).

- When inspecting to comply with this Safety Alert, and when performing daily pre-use inspections, the Operator shall **visually inspect** the turret pedestal for any signs of metal fatigue (cracks/distortion/significant rust). Should the inspection reveal a possible defect, be sure to take pictures and report findings to your local Mechanic.

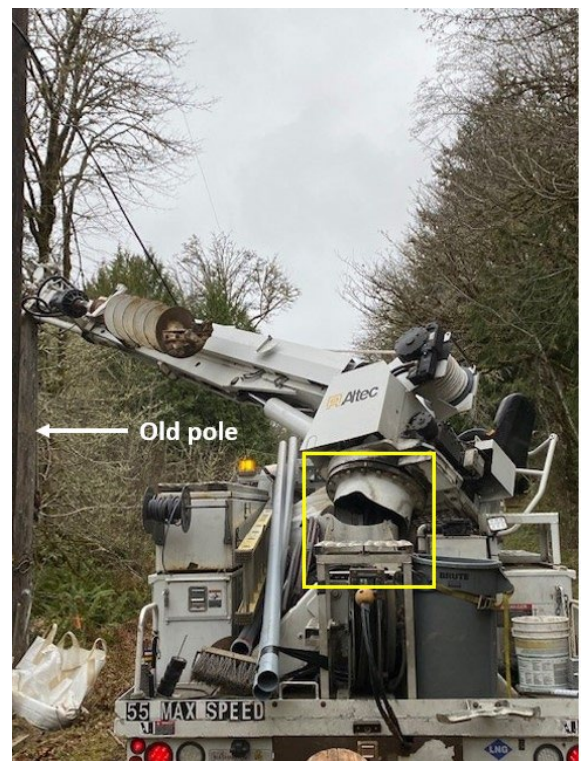
The crew had successfully replaced a 3-phase pole and was in the process of pulling the old cedar pole butt section that had been topped about 15' above ground. At the time of the pick at-tempt, the 2nd stage of the boom was extended about 3/4 way out and at a 35 degree angle. When applying pressure to the winchline, the old pole butt rose about 6 inches when suddenly the turret pedestal of the digger derrick broke, detaching the boom from the truck. The tip of the boom came to rest on the top of the old pole and the operators platform came to rest against a sand bag directly in front of the turret. The Foreman notified the Base Manager of the incident and a second line truck and a Mechanic was called to the scene. The second line truck removed the detached boom and loaded it on the pole trailer. There were no injuries and the incident is under investigation.

With the boom at a 35 degree angle and second stage approximately 3/4's of the way extended and a winch line rated at 13,000 LB.'s, the lift was well within its safe load parameters. In addition in 2019, the manufacturer added struts to fortify the turret pedestal for added safety capacity. In this incident, the failure was a catastrophic metal fatigue failure as indicated in the pictures. In addition, the crew practiced good situational awareness by having all other employees out of the bight and in the clear.

- Utilize best practices by using the pole butt jack to insure that the boom does not see overloading when breaking loose and removing a pole.
- Make discussing "mechanical" and gravity" energies a priority during our tailboard hazard analysis discussions.
- Booms are meant for vertical, in line lifts only without side strain. Do not use the claws to rock the pole back and forth to assist in pulling operation.
- If using the boom to lift the pole, the winch line should not be engaged (do not wind up). This ensures the hydraulic overpressure lockout is providing protection.
