RE:  
**Notice of Joint Red Book  
Safety Committee Meetings  
for March 2026**

**MEETING MINUTES**  
**IBEW 47-1245 / WLCC-NECA JOINT SAFETY COMMITTEE**  
**December 9, 2025,**  
**Cal-Nevada JATC – Woodland Training Center**

The updated **Accident & Incident Reports** is attached hereto as **Exhibit A**.

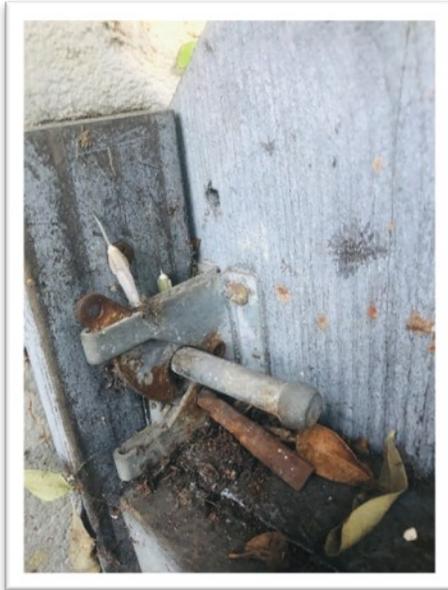
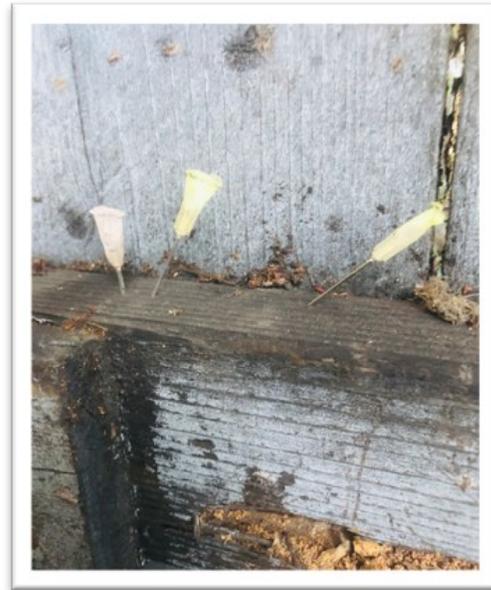
[Area where needles were placed]

**ACTIVITY:** A team member was investigating a potential gas leak at a residential location within SDG&E's service territory.

1. Don't place your hands anywhere you haven't visually inspected first. A mirror can be used when possible to improve visibility in hard-to-see areas.
2. Wear appropriate gloves to safeguard your hands, particularly when reaching into areas with limited or no visibility.
3. Maintain situational awareness at all times and continually scan for potential job-site hazards.

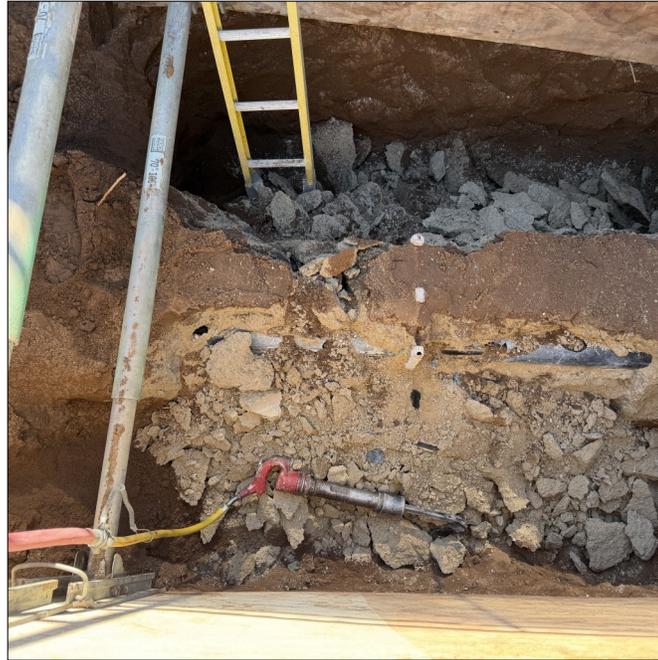
[Area where damage occurred]

**ACTIVITY:** A Standby Lineman (SBL) was performing chipping operations.

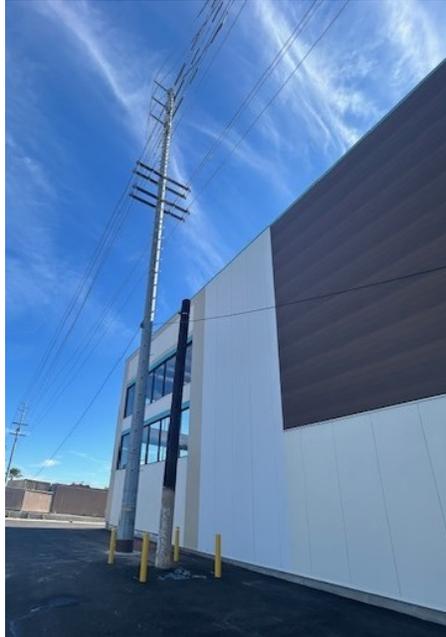
Location of incident

**ACTIVITY:** Crew was tasked with setting the middle section and top of a 110' pole and transfer wire.
