**Notice of Joint Red Book  
Safety Committee Meetings  
for September 2026**

**MEETING MINUTES**  
**IBEW 47-1245 / WLCC-NECA JOINT SAFETY COMMITTEE**  
**June 3, 2026,**  
**Cal-Nevada JATC – Woodland Training Center**

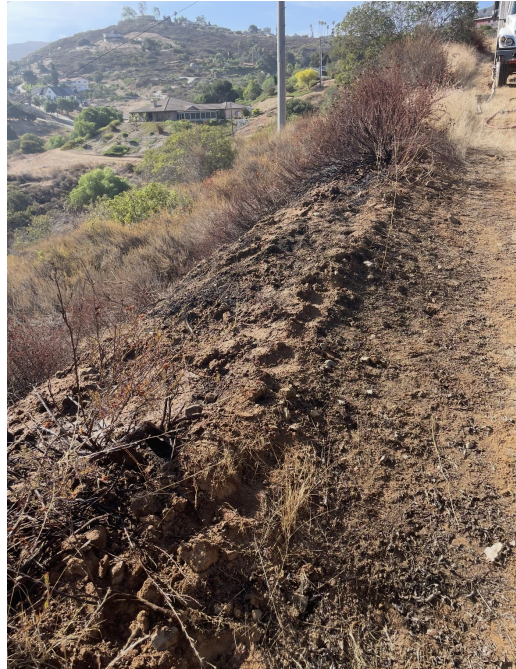
Area where fire occurred during annual grading operations

**ACTIVITY:** Vegetation management and annual road grading activities were being performed along an access road using a skid steer equipped with a mower attachment.

1. Maintain dedicated fire suppression resources in close proximity to vegetation management and grading activities.
2. Reinforce team awareness for early signs of smoke, heat, or ignition sources during mechanical vegetation clearing.

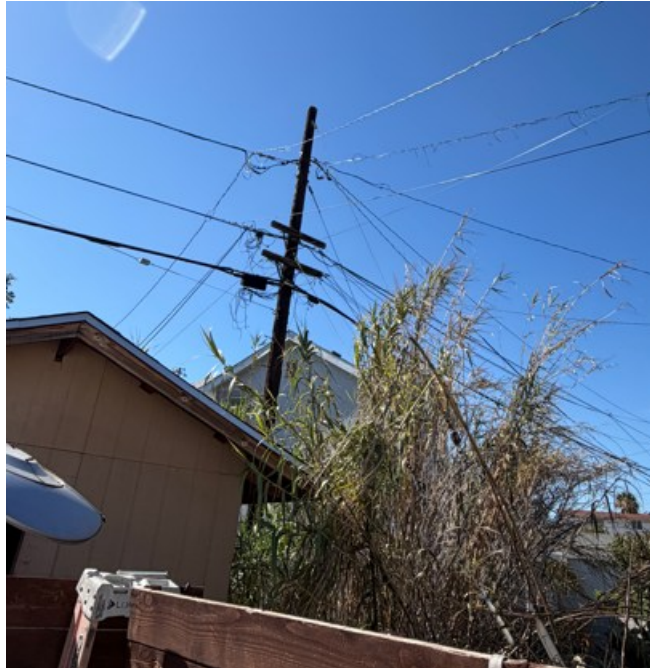
[Electric incident resulting in fire damage]

**ACTIVITY:** On 06/22/26 two contracted crews were engaged in overhead (OH) scope of work involving pole replacement and secondary reconductor installation.

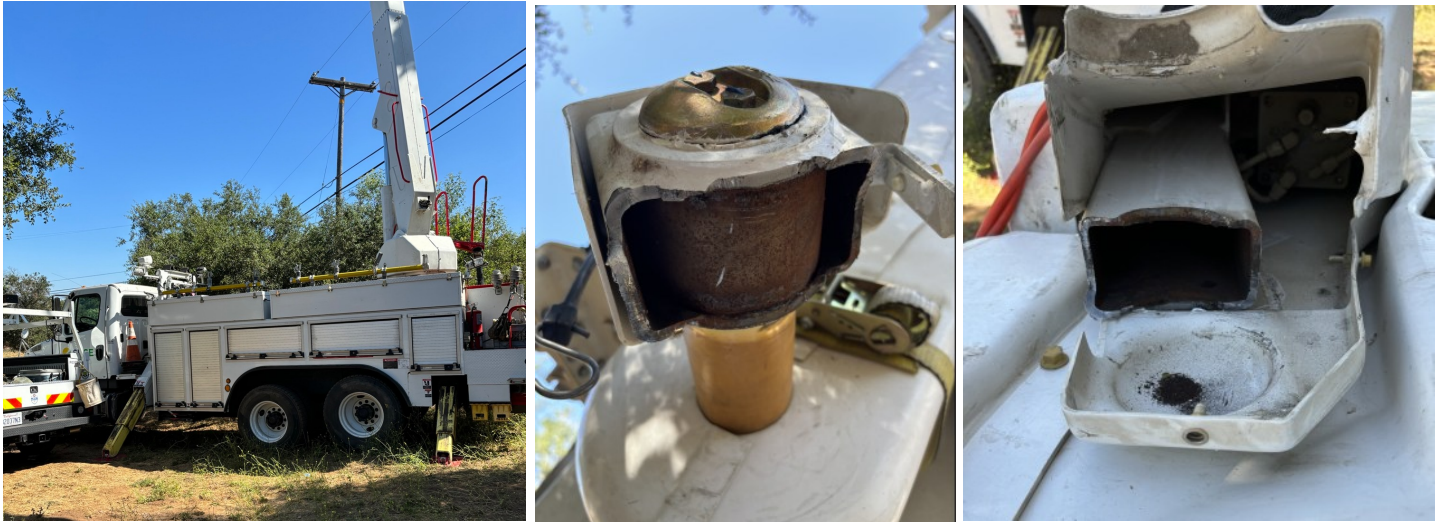
**ACTIVITY:** An internal SDG&E crew was performing overhead line work.

**INCIDENT SUMMARY:** On June 28, 2024, a Lineman and apprentice were working aloft in a two-person aerial lift when the bucket separated from the end of the boom at the mounting arm/pin. The bucket dropped and was hanging from the hydraulic hoses leaving the two line workers suspended in their personal fall arrest systems. The two workers were rescued by another lineman in a service bucket and lowered to the ground one at a time. The involved equipment was a bucket truck with an Altec 72' two-person aerial lift (A72) put in service in 2021.

**POTENTIAL MITIGATION(S):** SDG&E will keep these 13 units out of service until it can assess the risk associated with their continued operation.

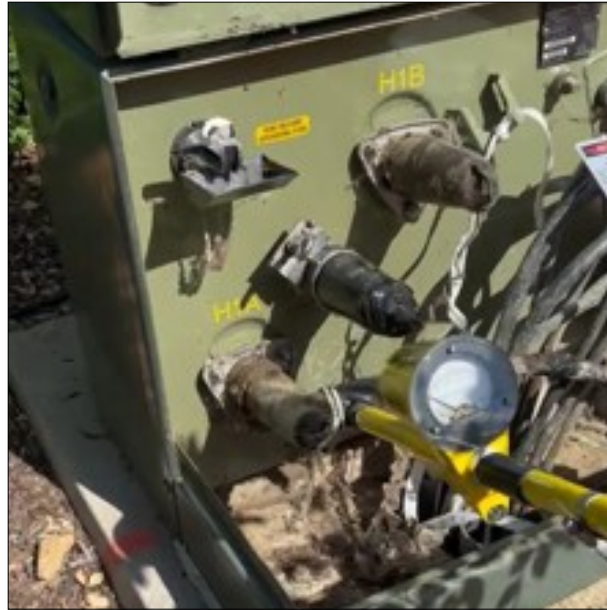
Testing for voltage with the volt meter at the transformer in question

**ACTIVITY:** A contracted distribution electric crew was tasked with installing an underground service to an accessory dwelling unit (ADU).

1. Proper testing conducted prior to engaging in work.
2. Utilization of appropriate PPE.
3. Effective tailboard discussion and clear communication to understand scope, risks, and controls.

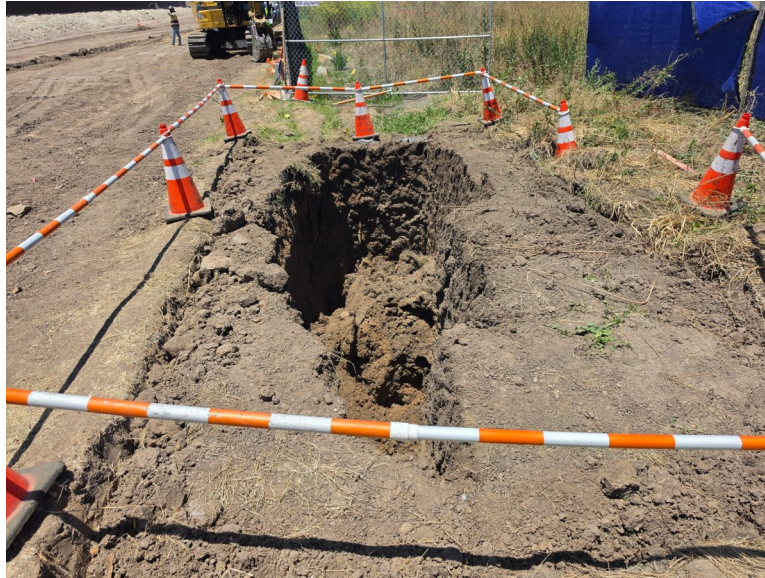
[Trench Collapse]

**ACTIVITY:** Vacuum Truck Operator potholing over a gas pipeline.

5. Be mindful of equipment and vehicle placement around excavations, maintaining appropriate distance to help reduce added stress on trench walls and support overall ground stability.

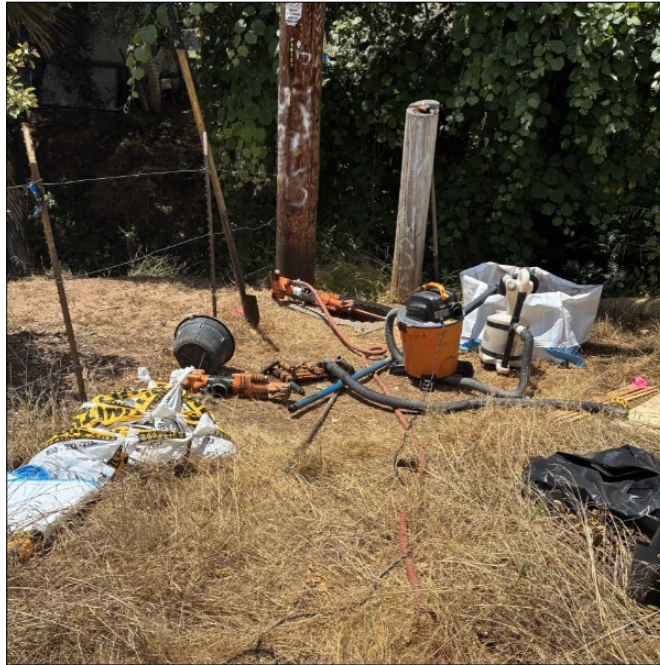
Excavation site with dry vegetation

**ACTIVITY:** Excavation / pole hole digging in a wildland area with dry vegetation.
