**Notice of Joint Safety  
Committee Meeting for 2022**

**MEETING MINUTES**  
**IBEW 47-1245 / WLCC-NECA JOINT SAFETY COMMITTEE**  
**June 15, 2022**  
**Cal-Nevada JATC – Woodland Training Center**

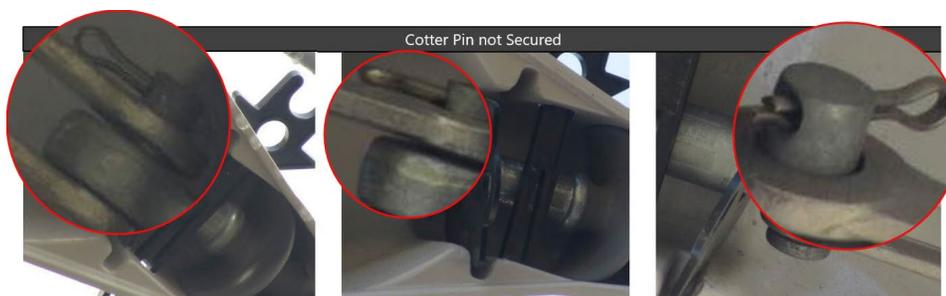
**Figure 1: Example of Backed-Out Cotter Pin**

- In some instances, the cotter key of the dead-end shoe was identified as coming out from the pin. See Figure 1. The assumption is that the anti-rotation clip was installed too close to the pin and cotter key and was likely pushed out during installation.
- The dead-end cover was installed incorrectly over too many sheds/skirts. Incorrect placement of the dead-end cover could affect placement of the anti-rotation clip.

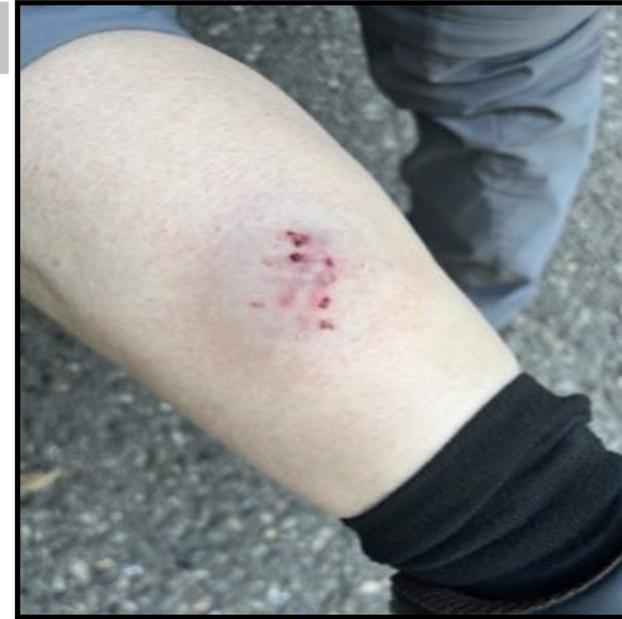
As part of fire mitigation work, an **aerial inspection crew was performing distribution pole inspections**. The crew entered an open property and talked with a worker on the far end of that property. There were **gates with "beware of dog" signs and all gates were open**. The crew drove to the end of the pole line and heard dogs bark in the area. **One crew member got out** and was going to notify the homeowner and as the crew member was walking, they **remembered they needed personal protective equipment (PPE)** from the vehicle. The crew member **turned around started to walk back** to get the PPE and the homeowner's **dog bit the crew member in the calf**, which broke the skin. Appropriate notifications were made. The crew used their first-aid kit to treat the wound then went to an urgent care provider where the crew member received basic first-aid and was released the same day with no limitations.

Figure 1. Injured crew member's calf with dog bite.

- Be prepared with medication (e.g., EPI pen) if needed for workers subject to allergic reaction(s)
- Seek first-aid/medical attention as soon as possible when bitten by a pest or animal
- Maintain situational awareness, review job sites, and continuously look for potential safety hazards
- When attacked by bees, hornets, or wasps, get to safety as quickly as possible, as bees release a chemical that attracts other bees when they sting
- If workers do get stung, have someone stay with them to watch for any allergic reactions. The area where the sting occurred should be washed with soap and water before attempting to remove the stinger. Run a clean fingernail or gauze over the sting to draw the stinger out
- Ice can be applied to a recent sting to help reduce swelling. Refrain from scratching or picking at a sting so that it doesn't become further irritated or infected

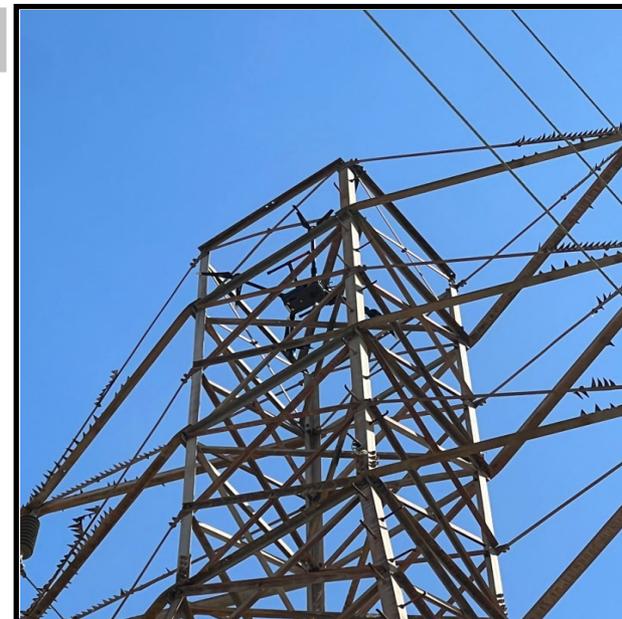
An **aerial inspection team inspecting transmission towers was positioning the drone** to capture an upward view of the tower. **Neither the pilot nor the visual observer had line of sight to the drone** as they descended it into position, and the drone pilot **inadvertently descended the drone onto the top of an adjacent lattice tower** (a much shorter structure located between the two taller towers). The **drone became lodged in the lattice portion of the tower**. Appropriate notifications were made. A project-wide safety stand down was called and a senior patrolman retrieved the drone. No injuries. No damage to the transmission tower. The drone sustained minimal damage.

Figure 2. Drone and transmission tower involved in incident.

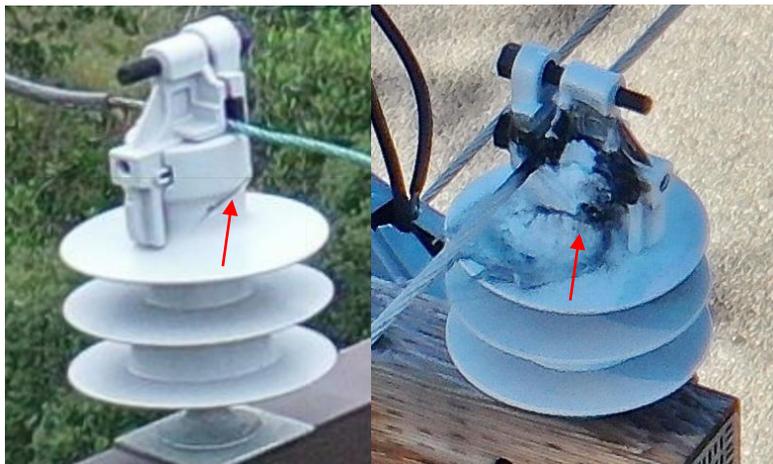
Aerial Inspections has notified Engineering and Construction Methods (CM) that, as of May 2022, 90 Priority 1 notifications have been generated to replace cracked/melted insulators. See Figure 1.

Figure 1: Cracked/Melted Insulator Example

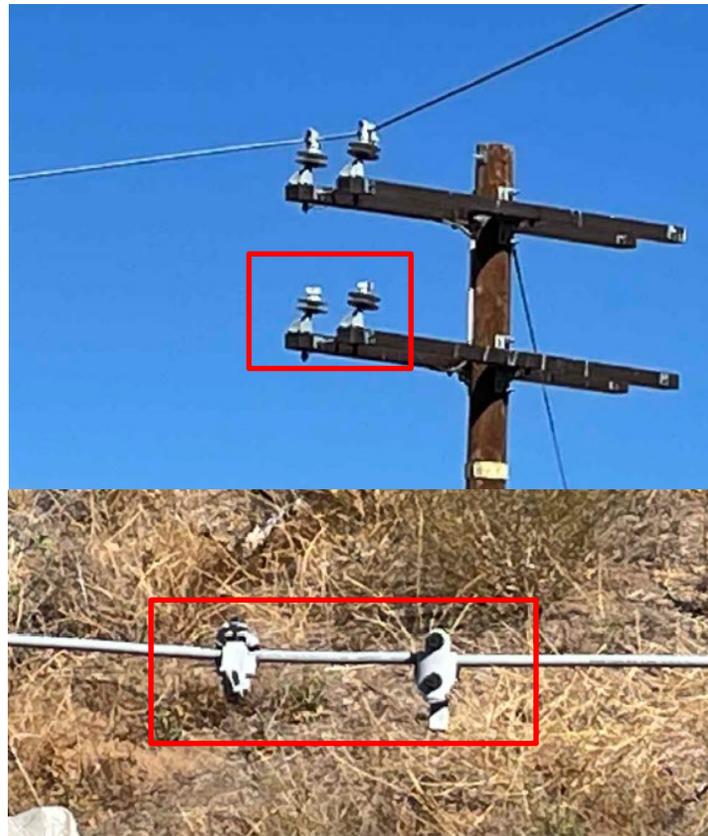
Additionally, Engineering and CM have been advised of other instances where excessive covered conductor angle deviations have resulted in insulators shearing off at the pin, resulting in phase-to-phase/ground contact or floating conductors. See Figure 2.

Figure 2: Sheared Insulator Clamps
