**Notice of Joint Safety  
Committee Meeting for 2022**

**MEETING MINUTES**  
**IBEW 47-1245 / WLCC-NECA JOINT SAFETY COMMITTEE**  
**June 15, 2022**  
**Cal-Nevada JATC – Woodland Training Center**

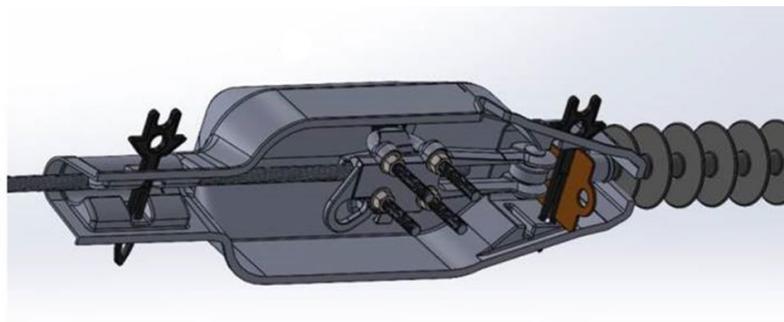
**Figure 3: Manufacturer Installation Instruction Example**

Install the dead-end cover per the provided manufacturer installation instructions. See Figure 3 below.

- Cover should be installed on the outside of the first skirt/shed of the dead-end insulator.
- The pins should be installed perpendicular to the line/shoe so the pin lays flat
- The anti-rotation clip will be installed **behind** the pin that holds the dead-end cover in place and on the flat part of the dead-end insulator. This will put the anti-rotation clip behind the two pin and cut outs of the dead-end cover. See Figure 4.
- The cotter key should be installed with the head of the key facing up or towards the dead-end insulator See Figure 5.

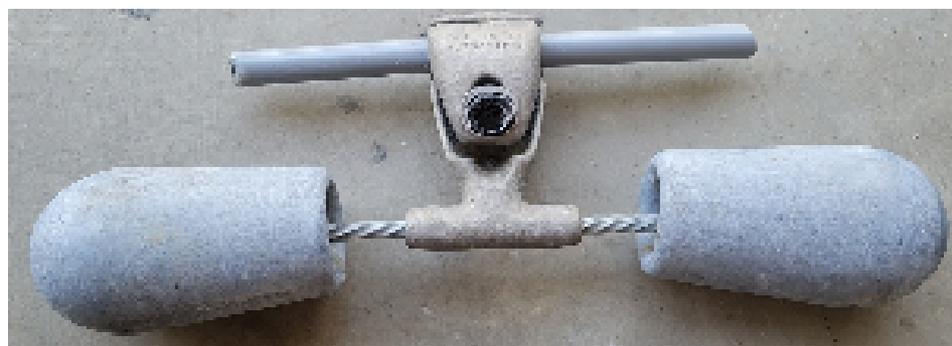
Figure 1: AFL Stockbridge Damper for 336 18/1 CC ACSR

SCE has been experiencing a shortage of Stockbridge dampers (refer to [HL-2021 2621](#)) for 336 ACSR Covered Conductor due to the high demand and supplier constraints. To meet these demands, engineering evaluated and approved AFL as a secondary source for the Stockbridge dampers. AFL Stockbridge (Shear Bolt Stockbridge) damper consists of an aluminum clamp and cast-iron weights pressed onto steel messenger wire for optimal mechanical performance (refer to Figure 1). The clamp is supplied with a Shear bolt; thus, no torque wrench is needed for installation. The damper can be hung on the cable, and the bolt tightened until the head shears off, ensuring proper installation. AFL dampers are designed and sized per conductor and tested in accordance with IEEE specifications. AFL Stockbridge damper for 336 ACSR (SAP #10214493) is 16" long and weighs 11 lbs. It is a symmetrical damper so that it can be installed with either weight facing the tower<sup>1</sup>.

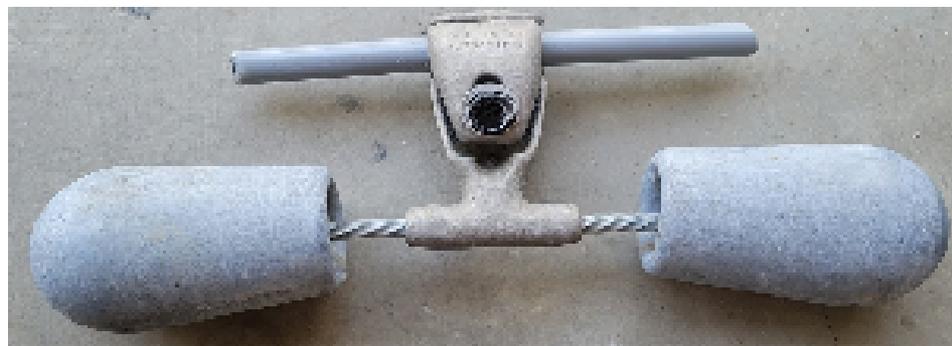
Figure 1: AFL Stockbridge Damper for 336 18/1 CC ACSR

SCE has been experiencing a shortage of Stockbridge dampers (refer to [HL-2021 2621](#)) for 336 ACSR Covered Conductor due to the high demand and supplier constraints. To meet these demands, engineering evaluated and approved AFL as a secondary source for the Stockbridge dampers. AFL Stockbridge (Shear Bolt Stockbridge) damper consists of an aluminum clamp and cast-iron weights pressed onto steel messenger wire for optimal mechanical performance (refer to Figure 1). The clamp is supplied with a Shear bolt; thus, no torque wrench is needed for installation. The damper can be hung on the cable, and the bolt tightened until the head shears off, ensuring proper installation. AFL dampers are designed and sized per conductor and tested in accordance with IEEE specifications. AFL Stockbridge damper for 336 ACSR (SAP #10214493) is 16" long and weighs 11 lbs. It is a symmetrical damper so that it can be installed with either weight facing the tower<sup>1</sup>.

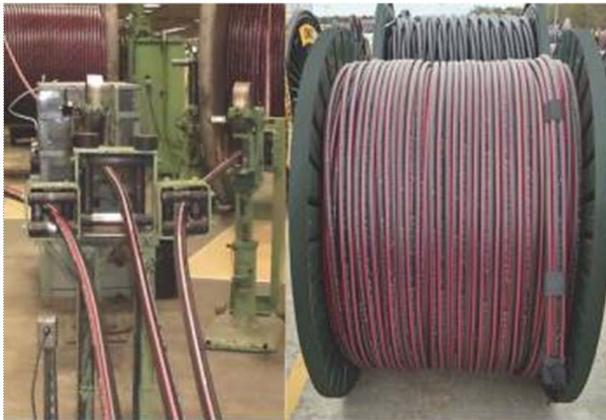
Figure 1: Parallel Manufacturing

To gain efficiencies and eliminate the possibility of the cable jamming during installation, some time ago SCE transitioned from parallel (Figure 1) to plex (Figure 2) manufacturing for most of its 600 V secondary cables.
